# SLOPE FAILURE IN EXPANSIVE MARLS

GONZALEZ DE VALLEJO\*, L., CAMPOS DE ORELLANA\*, J. A.

\* Empresa Nacional Adaro de Investigaciones Mineras, S.A.

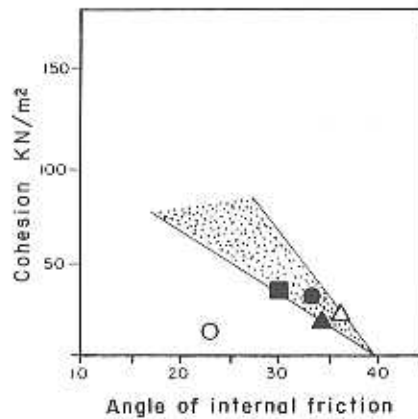
Fig. 1.— Results of shear stresses (residuals) from laboratory shear box tests and back analysis of failed slopes.

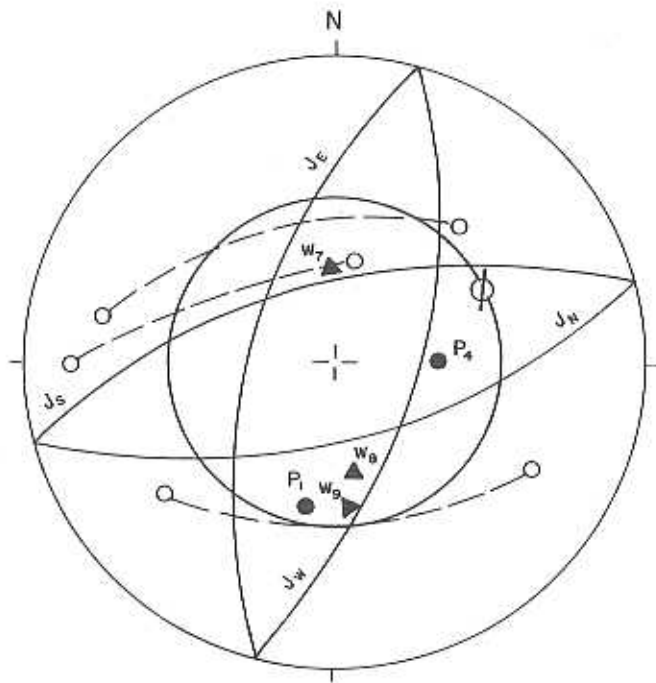
slope should require reinforcement to set back the factor of safety of plane  $P_1$ , which was 0.80 (Fig. 2 and table 1), to the factor of safety established by the design. It was estimated that a force of 2,200 Mg would be appropriate and obtained by means of postensioned anchors. Additional reinforcing bolts could be necessary to stabilised potential wedges (w8 and w9) in those places where the safety factor were 0.90. Similary, the South slope would require bolting for the unstable wedge w7 (F. of. S. 0.80). West slope would also need an additional force of 1,900 Mg to restitute the safety factor of plane  $P_4$  (0.90) by means of anchoring.

Fig. 2. - Stereoplot (Schmidt) of potential unstable planes and wedges anticipated by the design

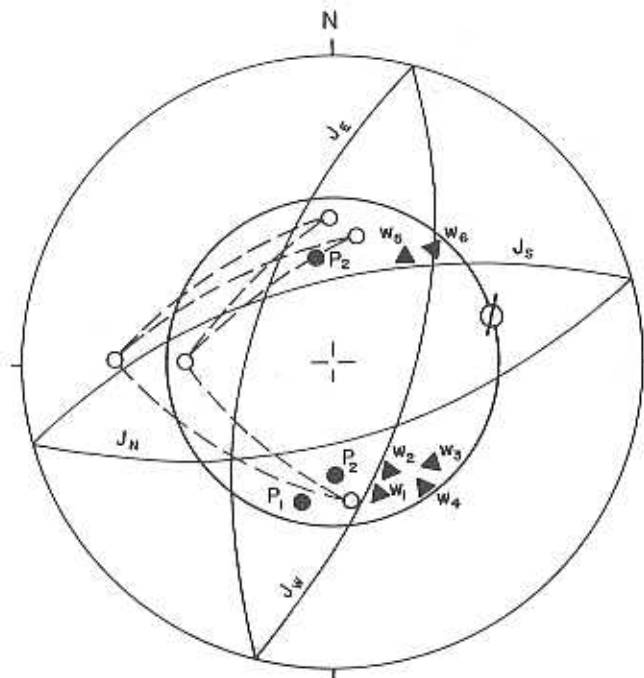
Fig. 3. - Stereoplot of planes and wedges which presented instability during the excavation. Note that only planes  $P_2$  and wedge  $w_1$  shown major failure problems (see legend from fig. 2)

Fig. 3 and Table 1 show stability analysis of the discontinuities existing during excavation. In all cases the factor of safety - could be higher than 1.2 under design conditions (Table 2). However, wedge  $W_1$  and Plane  $P_2$  failed.

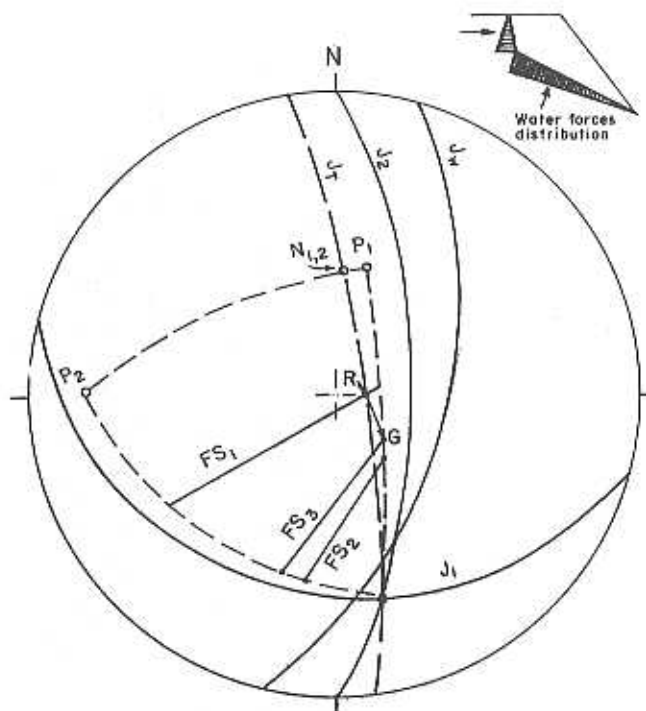
$15 \text{ m}^3$  of rubble rock on the West face of the cut. Fig. 3 and 4, and Table 3 present a synthesis of the stability analysis. Water pressure distributions are indicated in Fig. 4 for  $(C' + \beta')$  condition. In this case an acceleration "a" due to blasting expansion wave was also considered.

From these results it seems that overloaded blasting has been the main factor contributing to failure of wedge  $W_1$ . If it is assumed an acceleration of 0.20 g as usual for this situation, just a lower value, e.g. 0.18 g but with water forces acting on the slope can lead to a factor of safety of 1.0. However without water pressures it should be required an acceleration higher than 0.20, to get a factor of safety of 1.0 (Table 3).

Fig. 4. - Graphical analysis of the stability of wedge  $w$ , acting internal friction, cohesion, water pressure and acceleration due to blasting

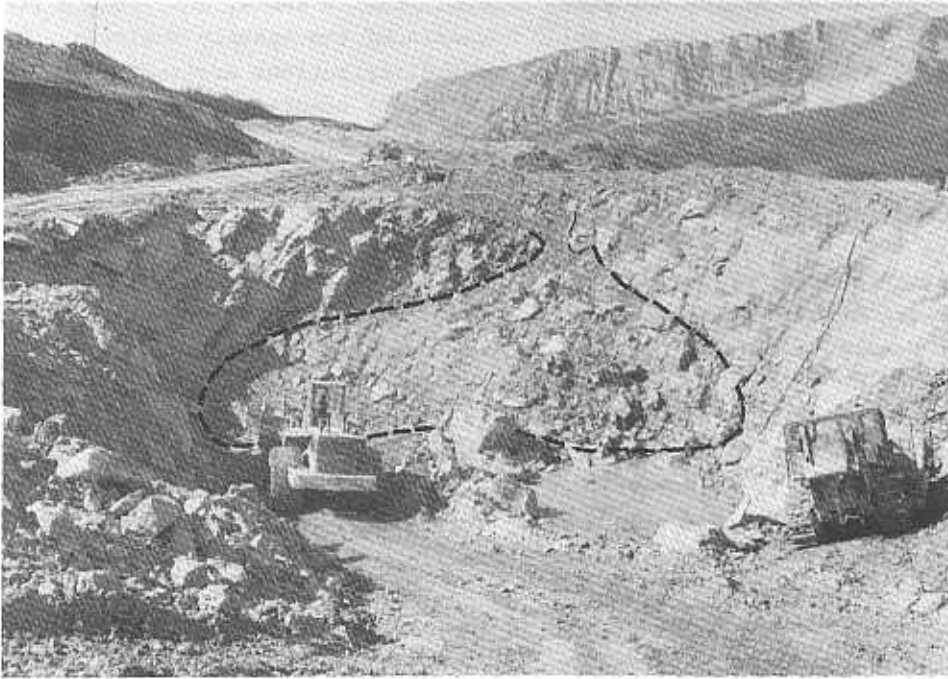
Fig. 5 shows the rock slide of wedge  $W_1$ . This wedge failure gave place to approximately

Fig. 5.- Wedge failure ( $w_1$ ) on the West face of the excavation

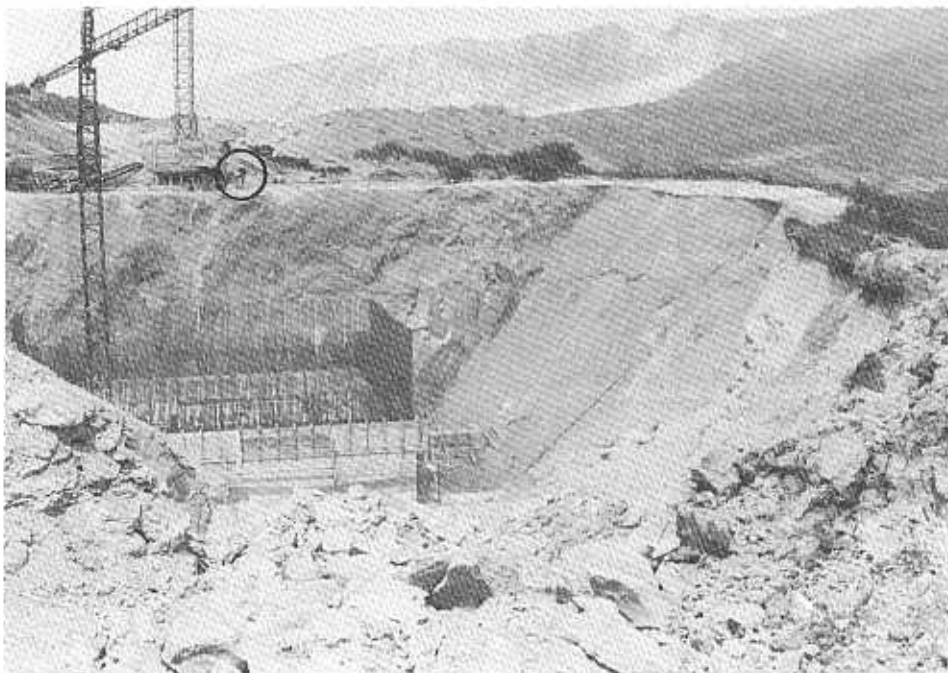
Fig. 6 shows the excavation after the failure of plane  $P_2$  located on the North slope -

Fig. 6.- Plane failure (P2) on the North face of the excavation (see man in the circle for scale).

when it reached a depth of 20 m. The volume of fallen rocks was about 400 m<sup>3</sup>. Table 3 summarized the stability conditions of this plane and it is shown that for design purposes (Table 2) the factor of safety should be higher than 2.0. It was concluded that the main reasons of the failure was the presence of water in a tension crack. Other possible reasons could be the loads of the lorries along a road sited just on the top of the excavation (Fig. 6), and the loosening of the rock by conventional blasting patterns.

- The importance of controlling the seepage of rainfall water in the excavation area.
- The need to of undertaking smooth blasting - and to consider the effects of blasting in the stability analysis of rock slopes in order not only to optimize the design but to recommend the best blasting schemes, too.
- The need of geotechnical advice during construction as a part of the design in order to accommodate the conditions anticipates during design and those prevailing during construction.
