Analysis and control of the deformational process of a weak rock mass affected by a large landslide

Luis I. González de Vallejo
Universidad Complutense, Madrid, Spain

ABSTRACT: A large landslide more than 1.000.000 m³ affecting an excavation in weak rocks has been investigated during several years. The evolution and characteristics of the movement have been studied, as well as the behaviour of the weak rock mass during the failure process.

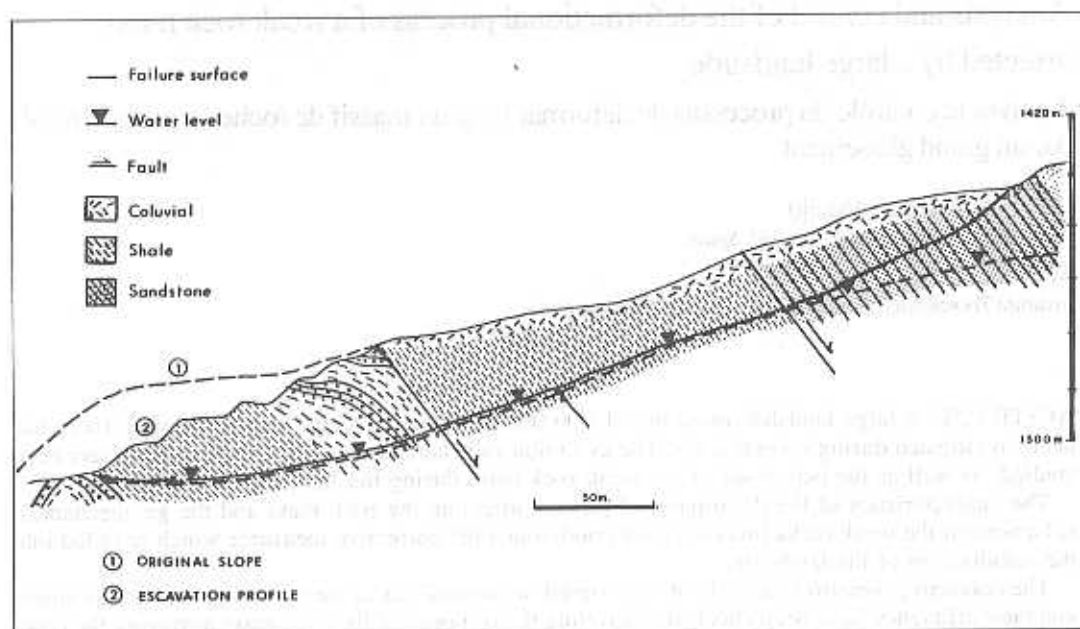
Figure 1. Geological section of the slope.

The slope is one of the flanks of an eroded and faulted anticline, the strata with variable dips generally between 45° and 90° to the interior of the slope (Figure 1). Two faults affect the slope, with a lot of accompanying little folds. The upper part of the slope is formed by competent sandstone layers which constitute a hard rock outcrop. Some joint sets affect the materials, mainly to the shales, which present a more elevated fracturation degree.

The first signs of instability appeared in April 1990, with the generation of large tension cracks in the upper part of the slope, about 300 m on the top of the excavation carried out in the toe of the slope (Figure 1), and coinciding with an outcrop of sandstones. During next weeks several new tension cracks were noticed, transversal and longitudinally to the natural slope, but no signs of instability affected to the excavated toe of the slope.

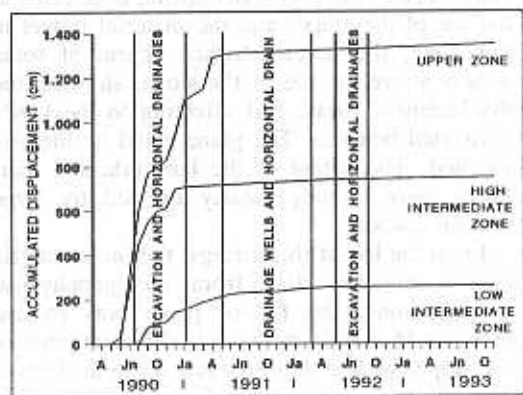
Figure 3. Evolution of the surface displacements of the slope in time.

As a consequence of this stabilization measures, the movement rate decreased considerably as can be seen in Figure 3, which shows the evolution of the surface displacements in time for almost four years, where the results of these actuations can be noticed from August 1990.

At the end of October, new tension cracks are detected in the lower benches of the new slope excavated, showing that the lower part of the slope were still unstable. The new tension cracks connected with the initial failure plane; the upper part of the initial landslide (were the material had been removed) did not present any sign of instability. In Figure 3 the curves from October 1990 represent this "second" step of the movement.

During December 1990, new excavations were carried out to remove part of the material at the toe and on the previous excavation, with a new decrease of the movement rate as show Figure 3. However, during next weeks the displacements increased when intense rainfall occurred in the area, while for normal rainfall there were no appreciable movement. From the rainfall curve in Figure 4, the relation between the ammount of rainfall and the surface displacements in time can

The curves of the evolution of the movement (Figure 3) show the effectiveness of the corrective measures carried out in the 1st stage (1990). Later, the analysis to modelize the behaviour of the slope indicated the necessity to carry out additional drainage (deep drainage) measures and the removal of material in determinated zones of the slope (2nd stage during 1991 and 1992).

Since 1991, the slope has not been affected by remarkable movement even during heavy rainy periods (Autum 1993 was specially rainy in the region). The superficial displacements represented in Figure 3 for 1991 to 1993 indicate that the slope is affected by a "residual" deformation, which do not represent any actual hazard for the slope.

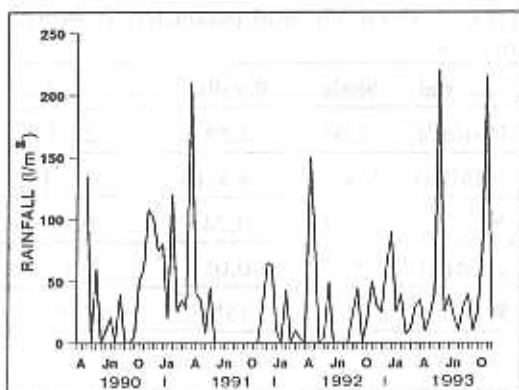
Figure 4. Rainfall data for the investigated period.

be deduced: the increase of the displacement rate occurred in March-April 1991, correspond to a rain peak with more than 200 l/m^2 in March.

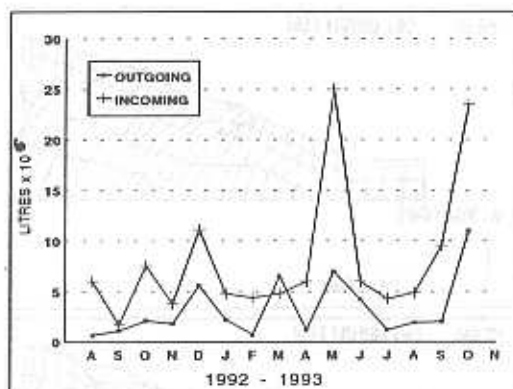
Figure 5. Curves showing the amount of water incoming (rain) and outgoing the landslide (drainage system)

Figure 5 shows the curves representing the volume of water fallen in the landslide and the volume of water drained by the drainage system installed in the slope. A good correlation can be deduced, and the imbalance between the two curves can be associated to the surface flow and to the infiltration of water into the rock mass.

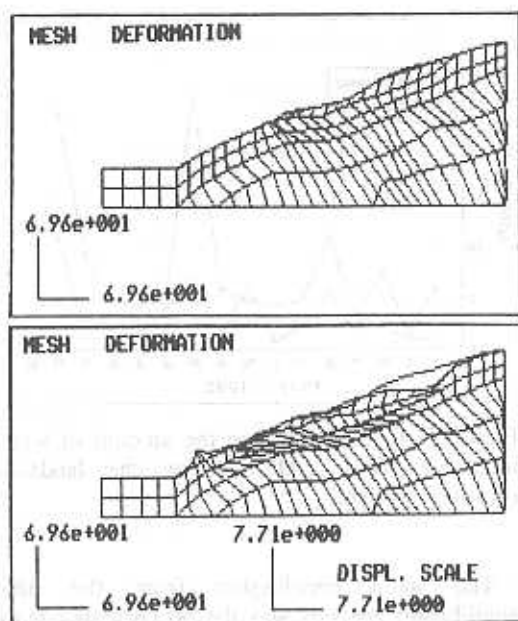
Figure 6. Initial (above) and deformed FE meshes for the back-analysis of the slope.

In Figure 6a the FE mesh corresponding to the model of the slope with the initial toe excavation (which caused the beginning of the landslide) is presented. The back-analysis carried out in order to modelize the actual deformational process, provided the values of the geomechanical parameters for the involved materials when the failure is reached. The correct modelling of the failure process was obtained, with the same deformational steps observed in the slope, mainly those features affecting to the upper part and to the toe of the slope. Figure 6b shows the deformed mesh when the instability of the model is reached in the analysis, with the main failure features affecting the slope and the failure plane coming out some meters above the toe.

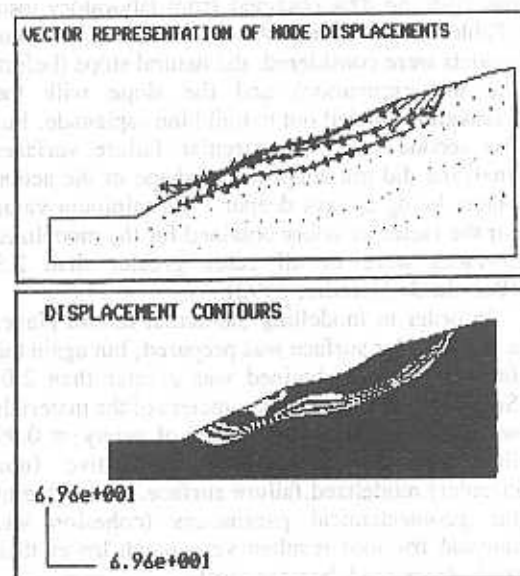
Figure 7. Displacement vectors (above) and displacement contours for the failure.

Figure 7a shows the displacement vectors for the step of the analysis when failure is reached

(F.S. < 1.0). These vectors indicate the type of movement affecting to the rock mass and the location of the failure surface; the portion of the rock mass which was not affected by the slide can also be seen, corresponding with what actually happened. Figure 7b shows the displacement contours, indicating again the location and shape of the failure, with the inflection of the failure surface which was also deduced from the geophysical investigations.
